Technical Bulletin #2

December 14, 2010

Terminal Connectors on the Limit Switch Printed Circuit Boards

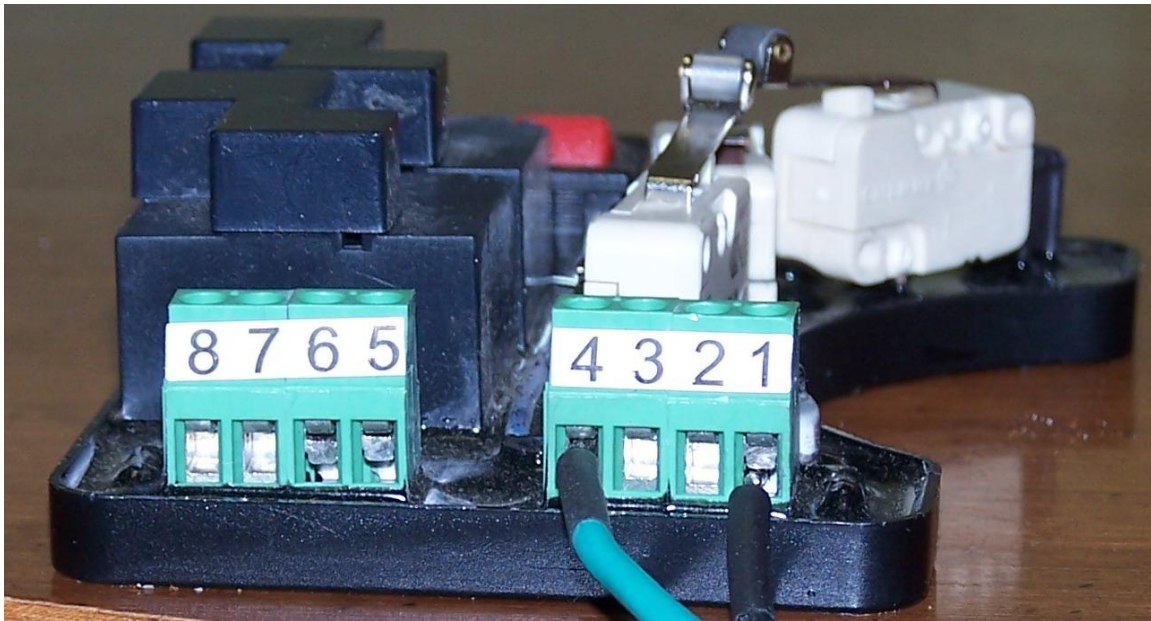
Sometimes the power lead may not be correctly inserted into the terminal block, resulting in faulty operation of the Di Drive. This can happen when the screws on the terminal block are not turned open far enough to properly open the gates into which the wires fit. The wires will then slide behind the gates and not make good contact.

In the attached picture gates 2,3,7 and 8 are open as they should be. Gates 5 & 6 are not open enough and the wire will slide behind the gates as shown in gate # 1. The wire in gate # 4 is secured properly in the grip of the gates.

This is the first thing to check if the switches are not working properly.
