di Drive

Technical Bulletin #3

June 2, 2012

Problem: Speed of vent or door is different on one side of house than the other side

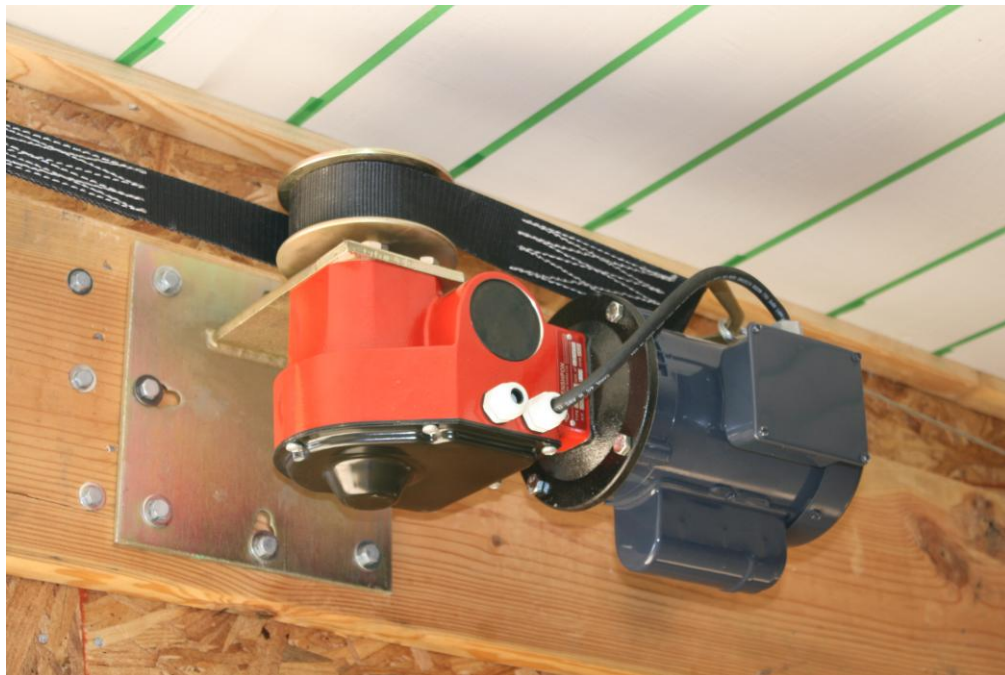
The gears **always** turn the same speed (2.06 rpm). The problem can be caused by more wraps of the belt on one drum than on the drum on the other side of the house. Even $\frac{1}{2}$ of a wrap can make a difference. It makes a slightly larger diameter drum and therefore a slightly faster belt. This is more noticeable with the longer black belts, because they have more wraps and larger diameters when fully closed.

Another cause may be if the cabling double-backs are not parallel. This can produce different rates of speed on the cables.
